## Wetland Mitigation Area D

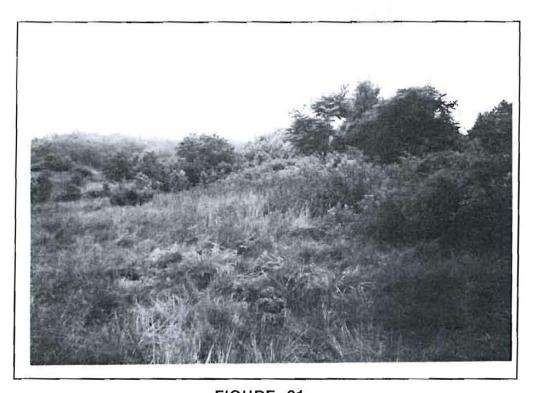
FIGURE 21

Wetland Mitigation Area D

Looking West at Terrace on Which the Bird-Husbands House Is Located;

Test Unit 5 Was Excavated at the Base of the Terrace
